Galley and Overhead Compartment Experiment Results - Full-Scale Transport Controlled Impact Demonstration

Roger M. Lloyd
RMS Technologies, Incorporated
Trevose, Pennsylvania

December 1985

1. Report No. DOT/FAA/CT-85/33	2. Government Accession No.	3. Recipient's Catalog No.	
4. Title and Subtitle Galley and Overhead Compartment Experiment Results - Full-Scale Transport Controlled Impact Demonstration		5. Report Date December 1985

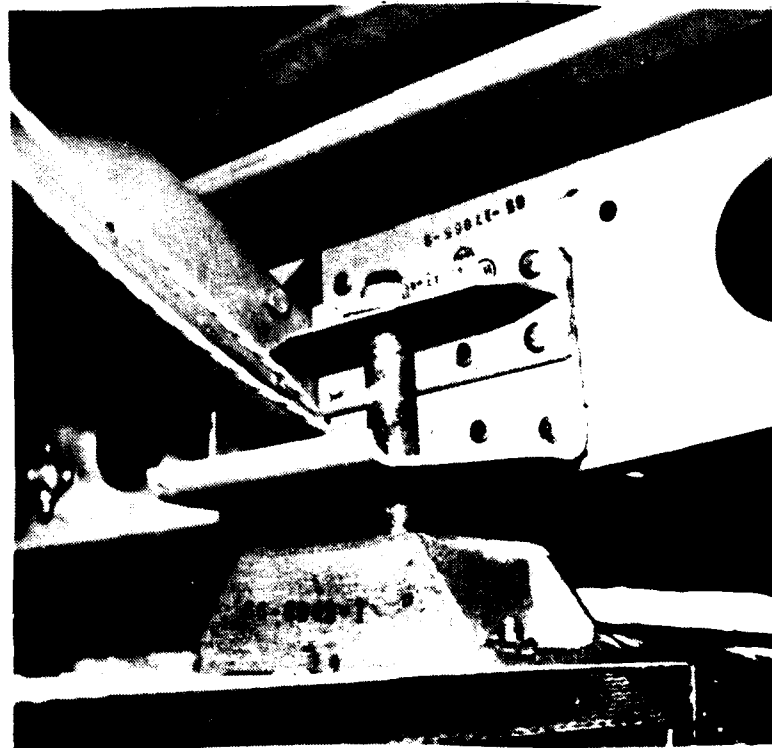
FIGURE 6. GALLEY UPPER ATTACHMENT FITTING

The two experimental galley modules were acquired from a Boeing 720 airplane located at Davis Monthan AFB. These galleys, which were made by the REF Company in Mineola, New York, were used as original equipment in many Boeing 720's, and therefore, were considered appropriate for a demonstration of their crashworthiness performance and content retention. Both galley modules, along with their interfacing structural members, were installed in the test aircraft in the location corresponding to those of the original installation. The forward galley was located at station 382 on the right side of the aircraft just forward of the galley service door. The aft galley was located at station 482 on the right side and just aft of the door (figure 5). An example of the upper attachment fittings is shown in figure 6. There were two upper attachment fittings on each galley located on the outboard top of the galley. They attached to the aircraft structure as shown in figures 7 and 8. The bottom of the galley was attached to the floor track by four studs near the corners of the galley which slid into the track and were held in place by a plate and retaining nut on the inside of the galley (figures 9 and 10).

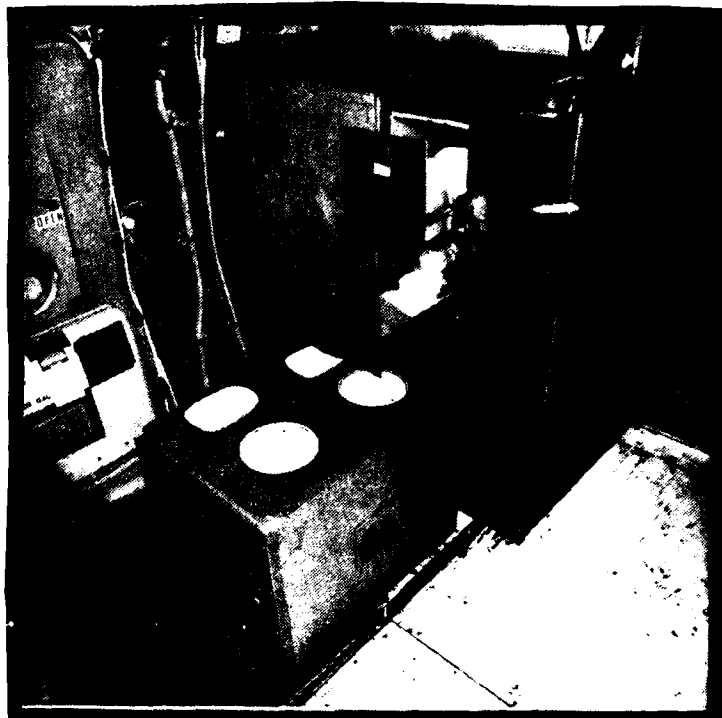
FIGURE 11. GALLEY LOADED WITH PLATES, TRAYS, ETC.

The forward and aft galleys were loaded to simulate in-service conditions. In the aft galley (forward facing) the above counter section was left empty while the lower individual food service modules were filled with actual trays, dishes, and silverware (no food) as identified under Table 3 (Figure 11). These contents weighed approximately 96.6 pounds. In the forward galley (aft facing), a coffee pot was placed in the above counter heating unit. However, the lower food service module area was not loaded with the normal food service equipment. Instead, the contents included a series of special "hazardous material" packages manufactured by the Lawrence Packing, Eli Lilly, and Dow Chemical companies (Figure 12). These packages are identified under Table 4. The total weight of these packages was approximately 147 pounds. (NOTE: The "hazardous material packages" contained non-hazardous jelled material and represented an experiment to determine the adequacy of such packages in resisting high impact conditions).

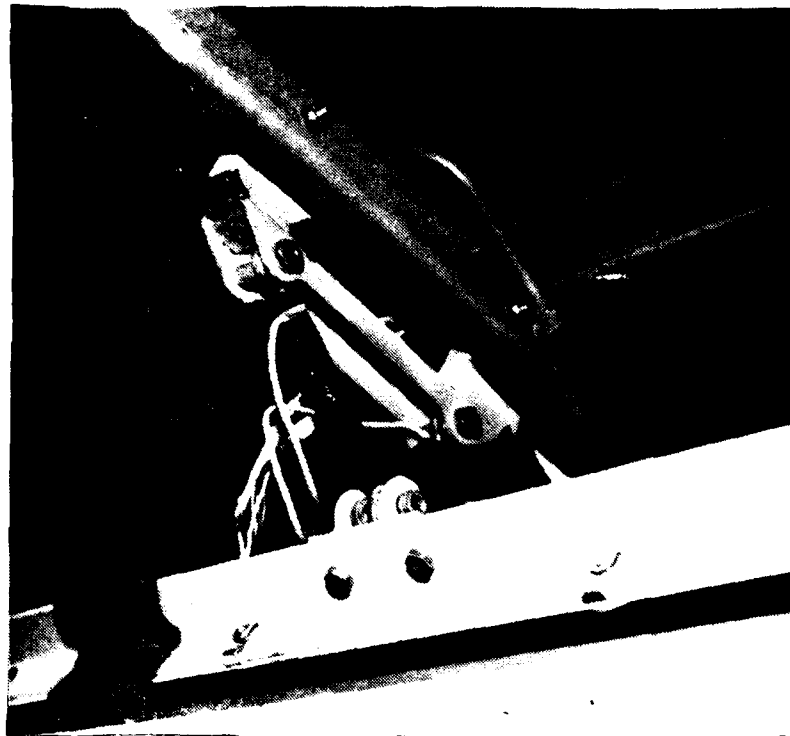
FIGURE 17. STRAIN GAGES UPPER SUPPORT LINKS

Similar to the galley modules, two enclosed type overhead stowage compartments were acquired from the same Boeing 720 located at Davis-Monthan AFB. The compartments and their structural hardware were installed in the test aircraft at locations corresponding to those of the original installation. This greatly facilitated the installation and allowed a realistic mounting scheme. The compartments were mounted on the right side of the aircraft just aft of the galleys (see figure 13). As shown in figures 14 through 16, the compartments were attached to the airframe by four sets of three support links and two drag links. One set of the support links was strain gaged to measure the forces in the supports during the crash. The strain gaged links are shown in figures 17 and 18.

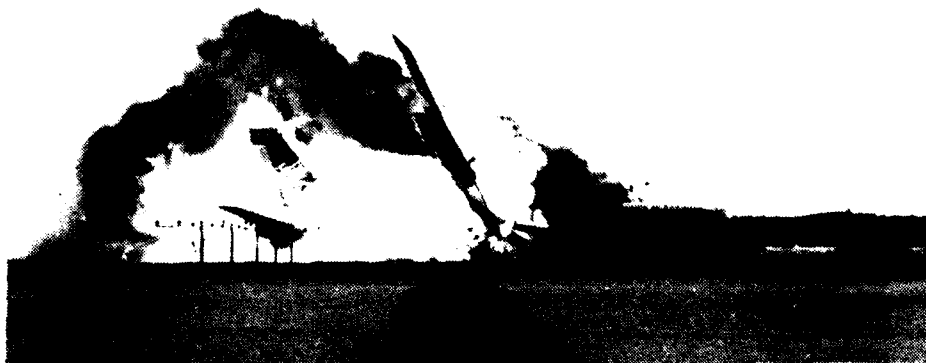
FIGURE 23. POST-CRASH FIRE

On final approach to the impact site, the aircraft had a speed of 152 knots, a sink rate of 17 ft/sec, and a 0 degree pitch attitude. Prior to impact, the aircraft experienced alignment problems which when corrected caused the left outboard engine to touch the ground first, 410 ft. short of the target as shown in figure 20. This initiated a left yawing motion of the aircraft. The forward portion of the fuselage (approximately B.S. 540) then touched down (figure 21) and the aircraft continued to yaw as it slid through the wing openers (figure 22). A fire erupted when a wing opener impacted the right inboard engine. The right wing, having been failed by the obstacles, separated, lifted upward as the aircraft continued to slide (figure 23), then plummeted to

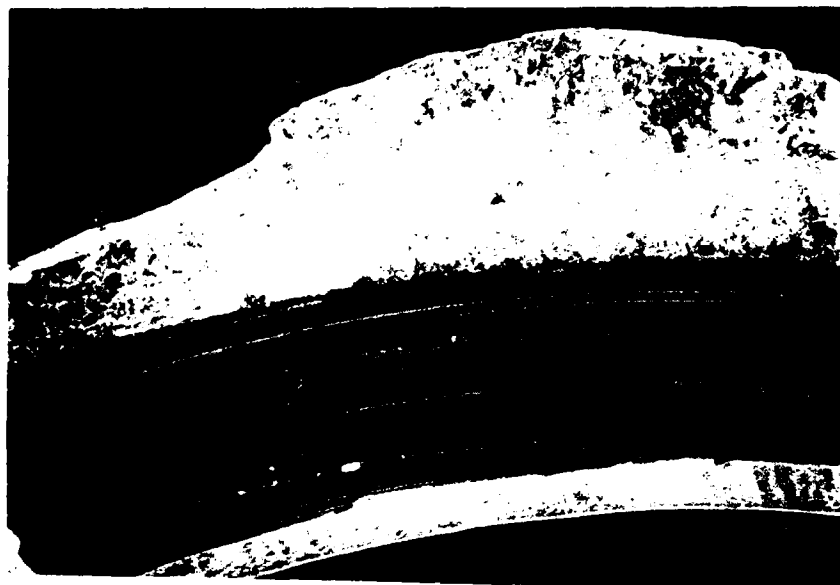
Subj: FAILURE OF OVERHEAD STORAGE COMPARTMENT SUPPORT LINKS
IN A BOEING 720 TRANSPORT PLANE
